CAPE LOOKOUT NATIONAL SEASHORE
Cape Lookout Village
FISHING COTTAGE #2

HISTORIC STRUCTURE REPORT

August 2003
Historical Architecture, Cultural Resources Division
Southeastern Regional Office
National Park Service

2002
Historic Structure Report
Fishing Cottage #2
Cape Lookout National Seashore
Cape Lookout Village
LCS#: 091833

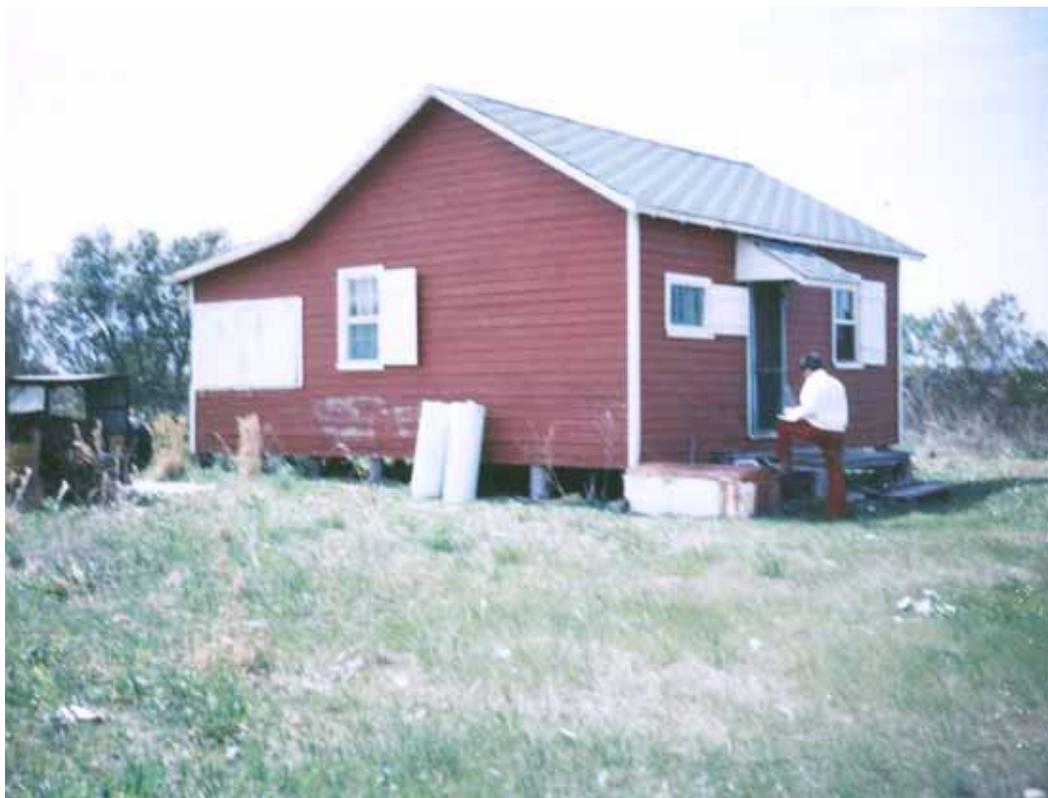
This building has undergone very few alterations since it was originally constructed, and nearly all of these appear to have occurred in the last twenty- five years. At some point, perhaps because of the growth of trees and shrubs on that side of the house in recent years, the steps to the porch were removed and the porch now functions as a utilitarian back porch to the house. At the southeast end of the porch, the wall has been altered and a ramp constructed so that all- terrain vehicles and other equipment can be stored on the porch. The house may have originally been painted red, its color in 1976, but has been painted white in recent years. The asphalt- composition roof covering has also been changed from bright blue shingles, which may have been original, to the present white roll- type roofing.

Figure 1 View west of house in 1976. (CALO Land files)

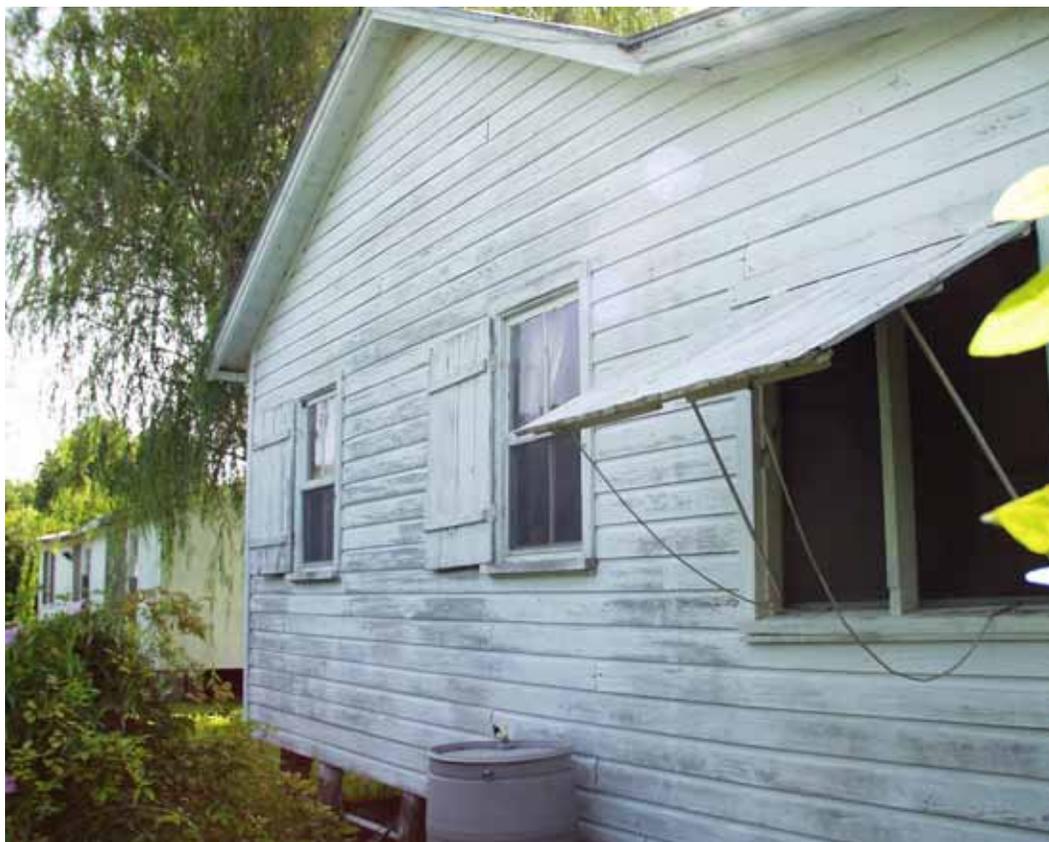
Figure 3 View east showing typical exterior finishes. (NPS-SERO-CR, 2002)

Exterior siding, window and door casing, and trim are intact and in good condition. Except for the porch, where more- extensive repairs may be needed, maintenance of painted finishes is all that is necessary.

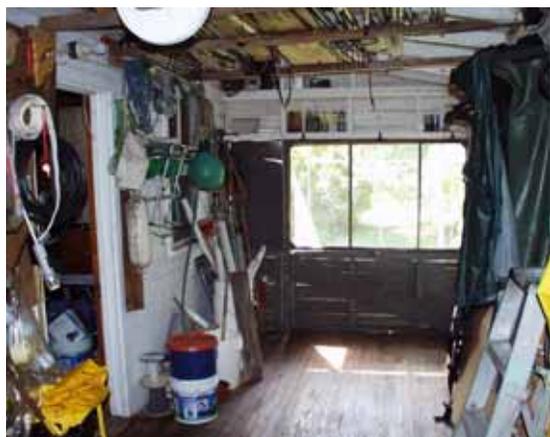
Figure 7 View to southeast on porch. (NPS-SERO-CR, 2002)

The northwest end of the porch has been partially enclosed in recent years to allow installation of a shower and toilet. At the southeast end, the knee wall has been cut and hinged to swing open and part of the wall above the screening has been removed to increase vertical clearance. These alterations are associated with the ramp that allows small vehicles to be stored on the porch.

- Reconstruct missing portions of southeast porch wall
- Remove plywood shutter at southeast end and replicate board- and- batten shutters to match original shutters elsewhere on the building

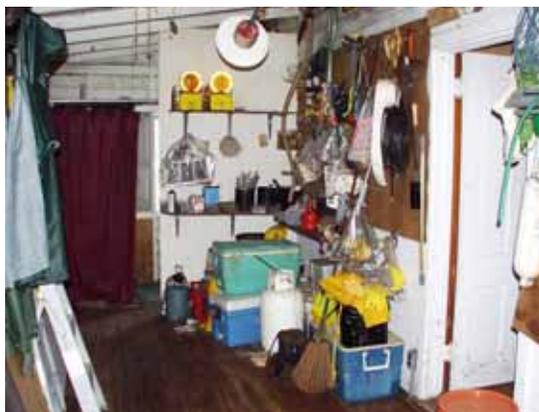
Figure 8 View to northwest on porch, showing enclosure for bath room at center rear. (NPS-SERO-CR, 2002)

Plumbing: The entire plumbing system should be rehabilitated. The existing bath area, which does not include a lavatory, should be replaced by a conventional bathroom in the same location. A framed wall, with a door opening, should be constructed approximately six feet from the northwest end of the back porch to create the space. The exposed back wall of the house and the outside knee walls and screening that form the other walls of the space can be repaired and preserved. The top-hinged exterior shutters are currently raised for light and air in the bath area, and they can continue to be used in the new bathroom without installing permanent windows.
