CAPE LOOKOUT NATIONAL SEASHORE
Cape Lookout Village
FISHING COTTAGE #2

HISTORIC STRUCTURE REPORT

August 2003
Historical Architecture, Cultural Resources Division
Southeastern Regional Office
National Park Service

2002
Historic Structure Report
Fishing Cottage #2
Cape Lookout National Seashore
Cape Lookout Village
LCS#: 091833

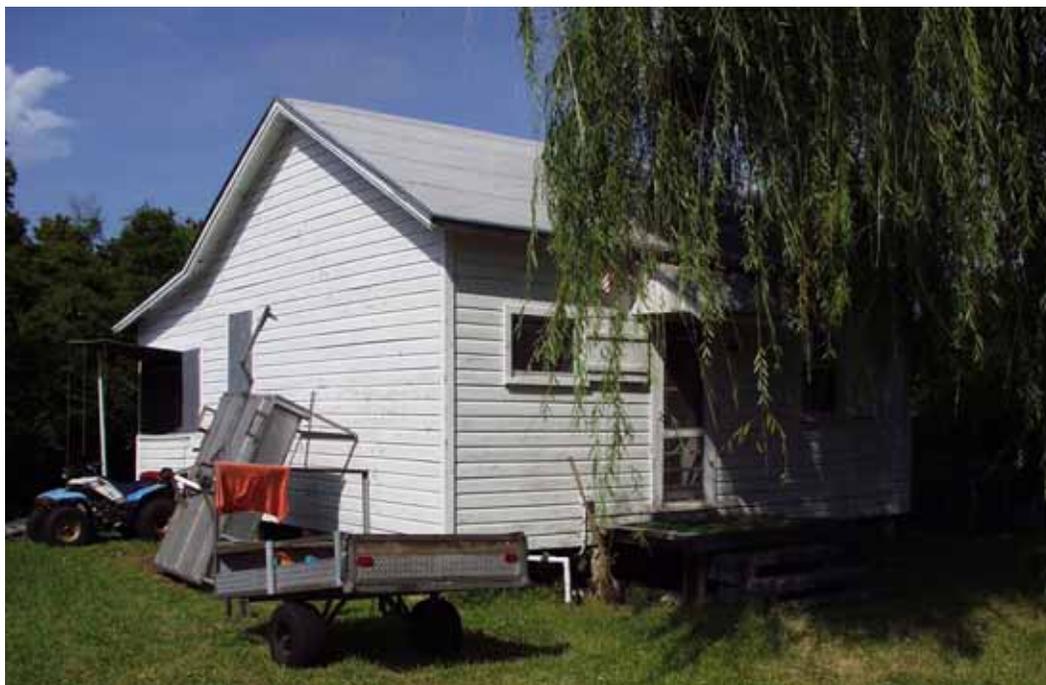
Built about 1950, Fishing Cottage #2 is a small, wood- framed, end- gabled structure located a few hundred yards northeast of the Coast Guard Station. The house is wood- framed with an end- gabled roof and a shed- roofed porch, continuing a vernacular tradition embodied in the Gaskill- Guthrie House, the Bryant House, and others of the older “fish houses” in the village. The porch door is now closed and inaccessible, and the main entrance to the house is at the small, sheltered stoop on the opposite side of the house. The footprint of the building, including the porch, measures about 22’- 4” by 26’- 2” and contains about 380 square feet of interior floor space plus about 165 square feet on the porch. Unlike most of the other private residences in the village, this house, though simple and utilitarian, is a sturdy, well- constructed building. Materials are generally uniform and of standard dimensions typical of the mid- twentieth century. In general, it is in very good condition, although threatened by termite activity and a failing roof covering.

Figure 1 View west. (NPS-SERO-CRS, 2002)

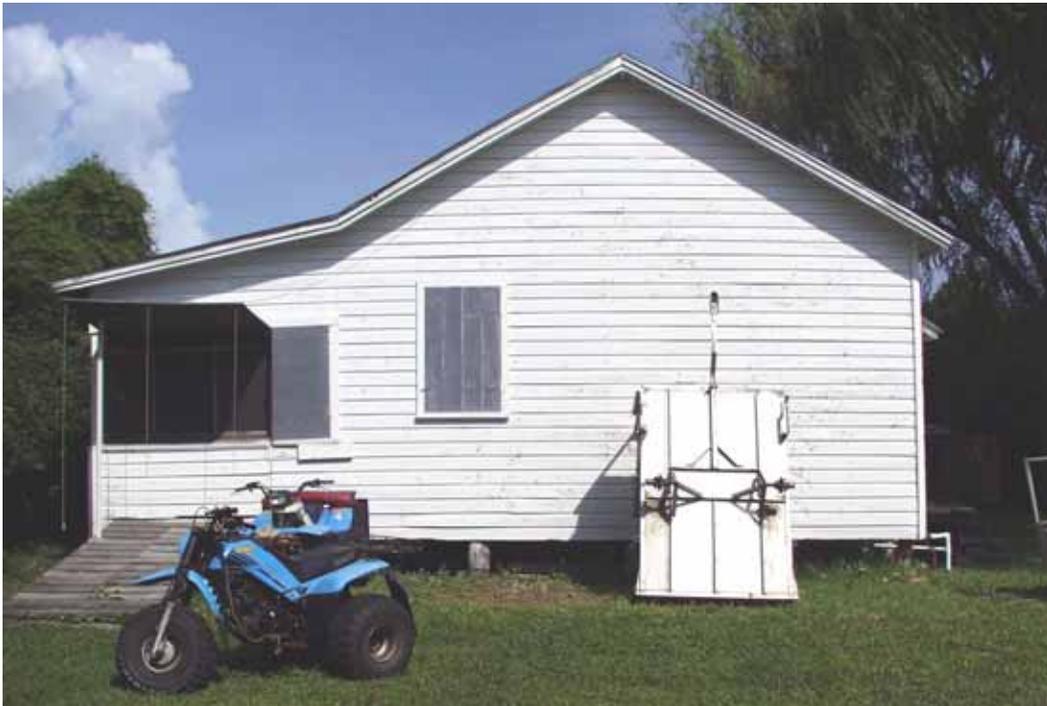
Figure 2 View northwest.
(NPS-SERO-CR, 2002)

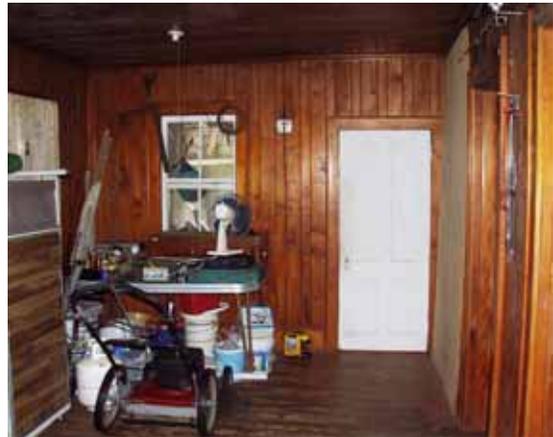
At the northeast end of the main room is a pine counter 6’- 11” long and 25” deep with a porcelain- enameled sink. Although the formica counter top is modern, the base cabinet, which is constructed of the same tongue- and- groove boards used on the walls and ceilings, appears to be original.

Figure 4 View to southwest in Room 100. (NPS-SERO-CR, 2002)

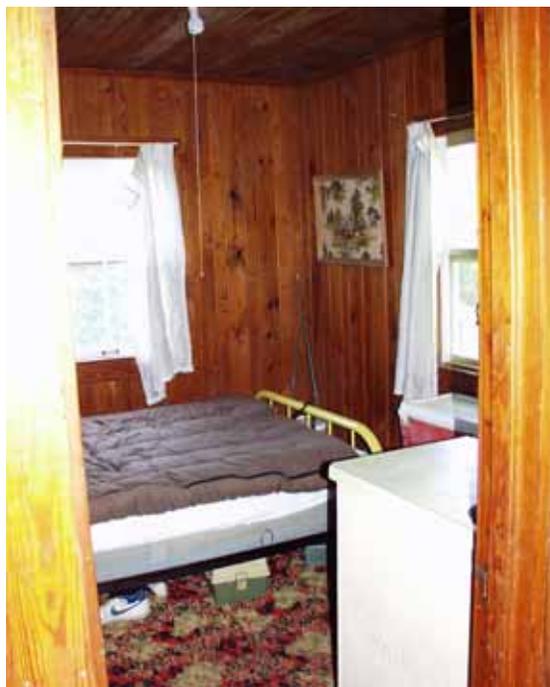
Figure 6 View to north in Room 101. Room 102 is finished in a similar fashion. (NPS-SERO-CR, 2002)

As with the exterior finishes, interior finishes are mostly intact and in good condition. Hidden damage may be discovered if the house is emptied of its contents, but it would probably be of very limited extent. Walls, ceilings, and floors were originally finished with a clear coat that is probably varnish. The coating is dirty and dull but could be simply cleaned and recoated without stripping the finish.

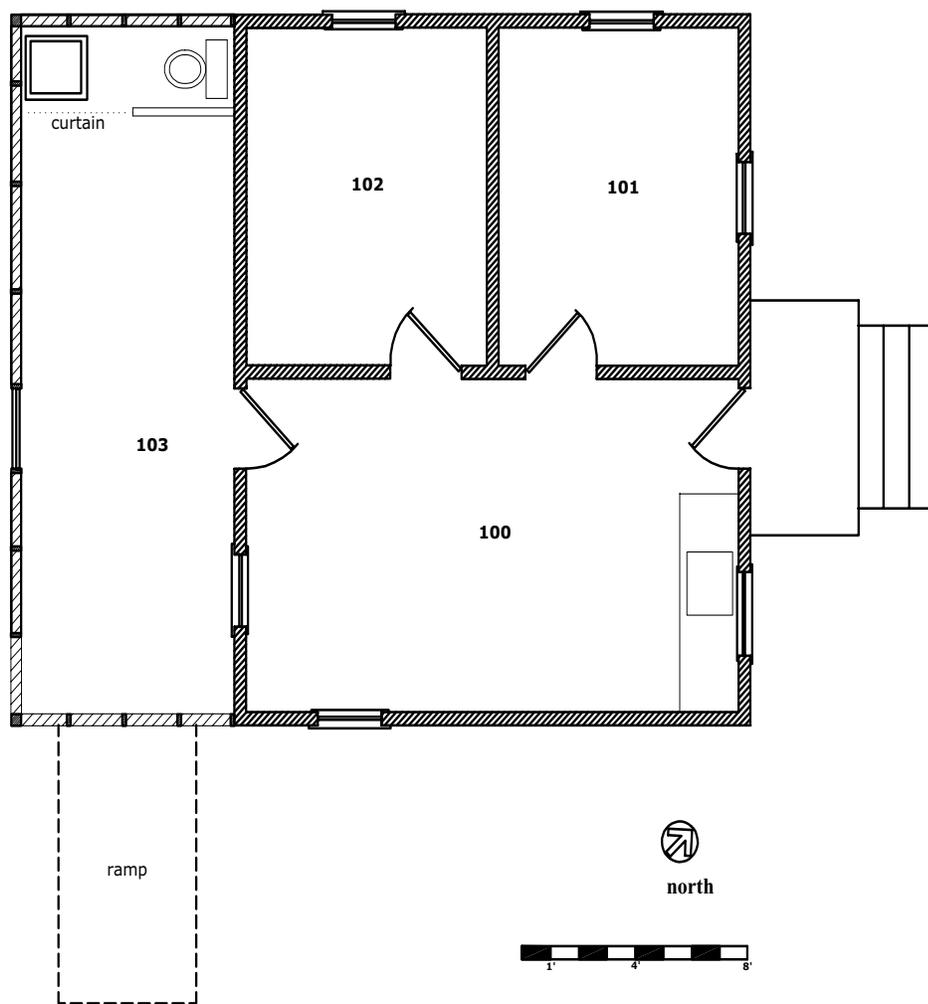
The northwest end of the porch has been partially enclosed in recent years to allow installation of a shower and toilet. At the southeast end, the knee wall has been cut and hinged to swing open and part of the wall above the screening has been removed to increase vertical clearance. These alterations are associated with the ramp that allows small vehicles to be stored on the porch.

Figure 9 Plan of existing house. (NPS-SERO-CRS, 2002)

- Reconstruct missing portions of southeast porch wall
- Remove plywood shutter at southeast end and replicate board- and- batten shutters to match original shutters elsewhere on the building
